Avalanche Details: [Cracking drift in Bridgers](#)

Bridger Range, 2020-12-12

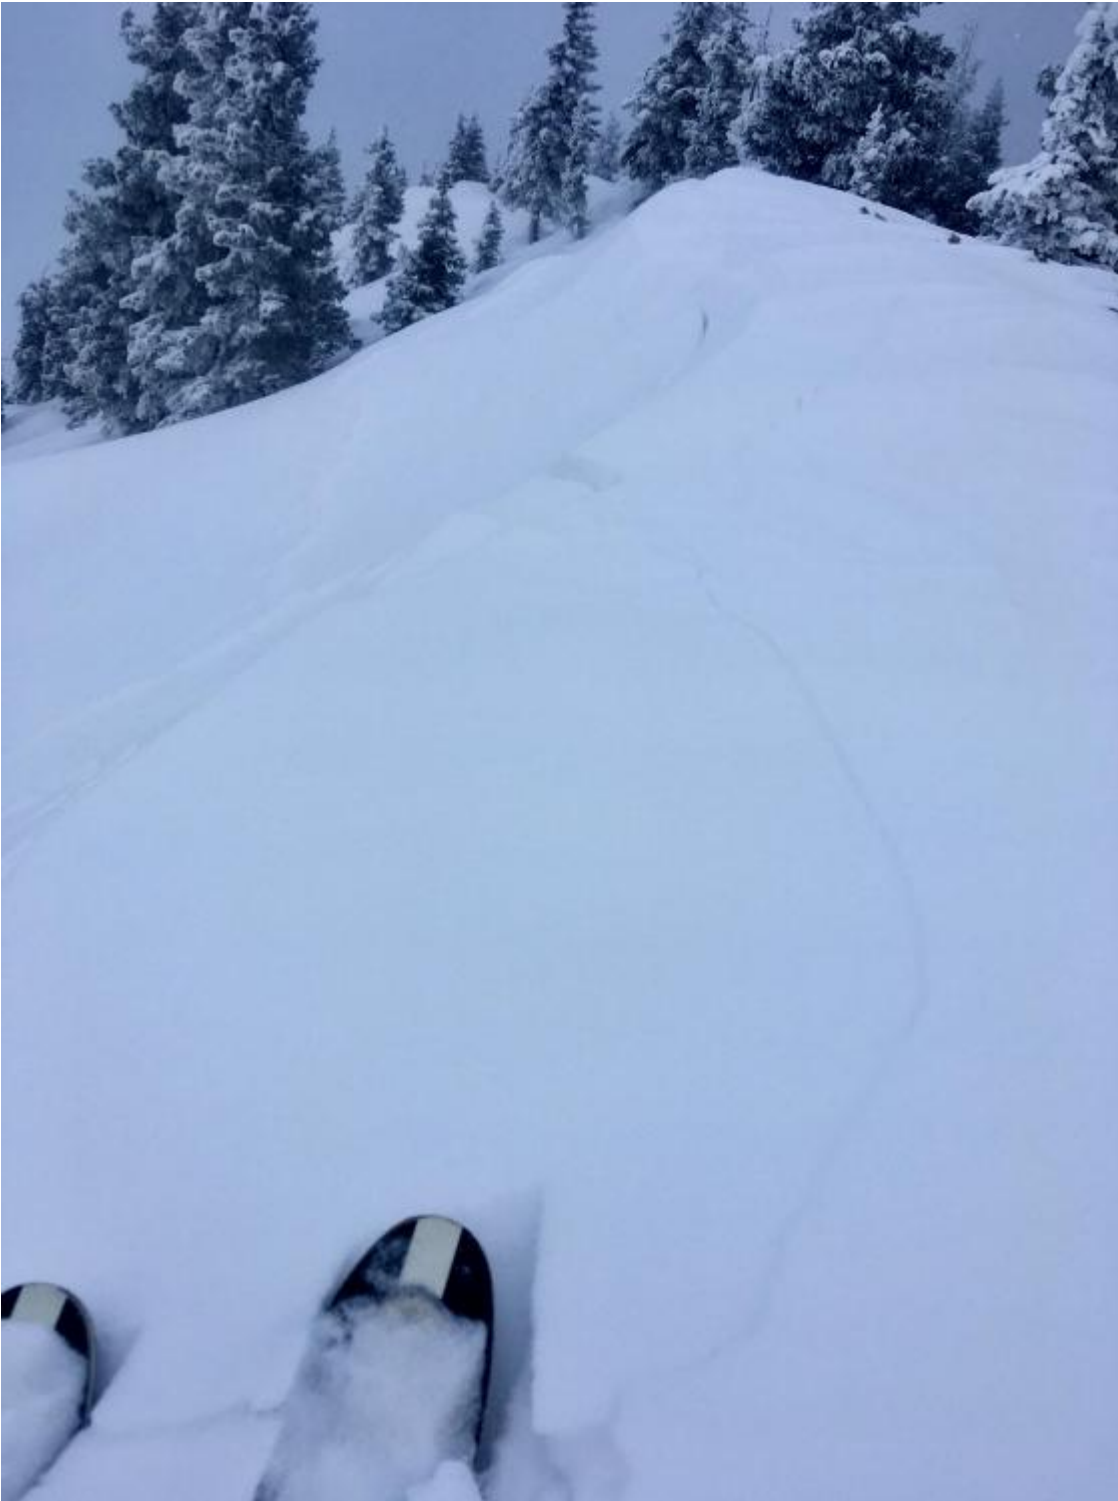
Light wind created soft drifts of new, low density snow near the ridgeline in the Bridger Range. This wind slab easily cracked when touched with skis, 20 feet along the ridge and 5-10 feet down, but didn't slide. This is a sign drifts will be unstable as they grow with more snow and wind. Photo: GNFAC
