Advisory Region Cooke City Longitude -109.95W Latitude 45.05N **Avalanche Details:** Large collapses near Cooke City Cooke City, 2022-11-13

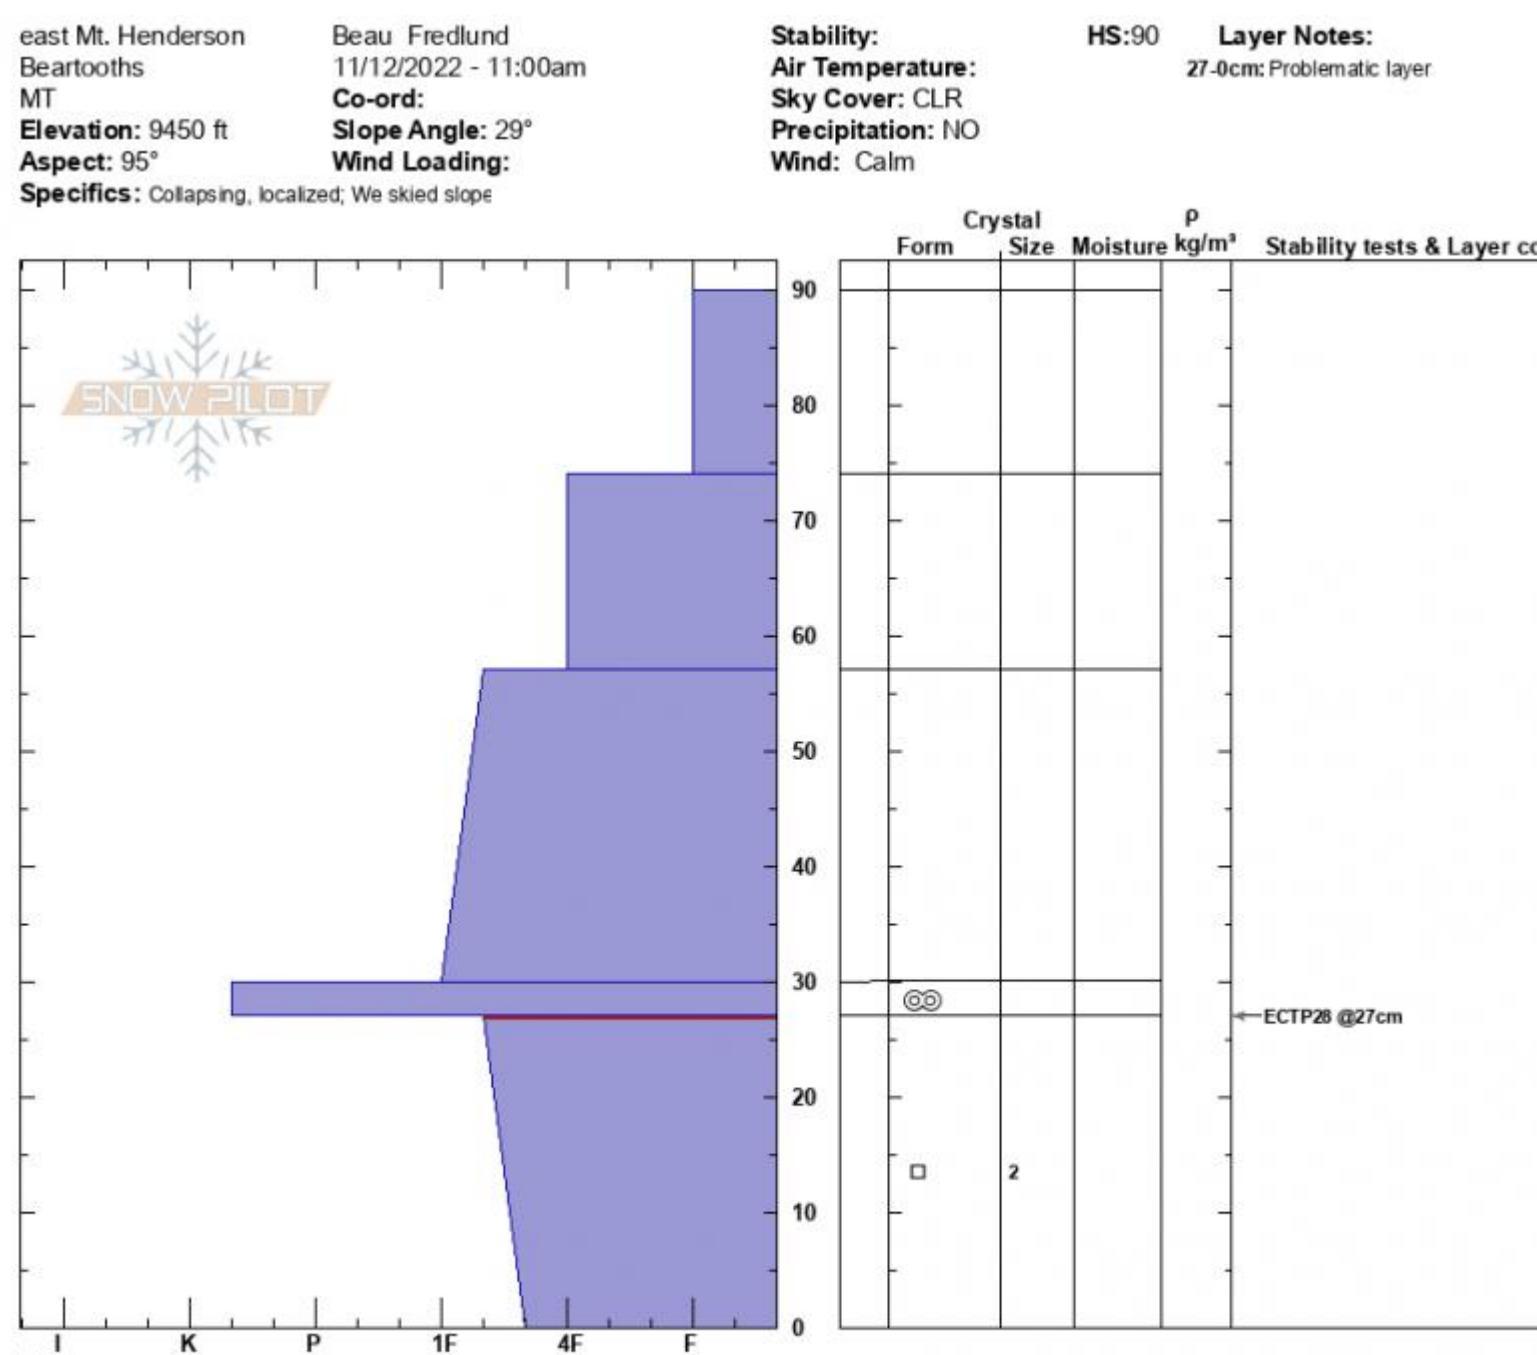
Notes: Snowpit location was in a relatively wind sheltered area. Above the snowpit location, much of the east facing terrain was significantly wind affected/ 1F s recent storm and not optimal for skiing. It seemed like all other aspects around the Mt. Henderson area (S, W and N) had less surface wind affect.

No avalanche activity observed.
